REP-REP-RAF1034-3400_CSIC_GRENZMUSTER Consult the boundary samples catalogue when assessing the appearance of carbon ceramic brake discs

VIN: Vehicle: 5' / F10 / Sedan / M5 / S63 / EUR / left-hand drive /
MANUAL / 2015 / -

Consult the
boundary
samples
catalogue when
assessing the
appearance of
carbon ceramic
brake discs

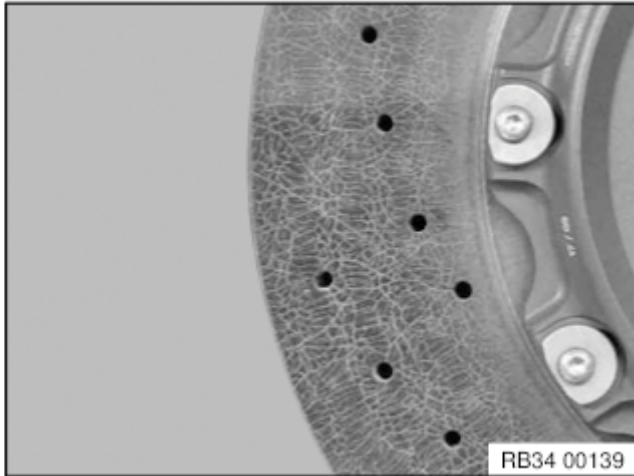
Tension relief structure:

base, the friction surfaces (even when new) are characterised by a harmless tension relief structure. Some relief cracks pass along the perforation bore holes.

The tension relief structure arises during the manufacturing process, starting from the brake disc surface, and is not a safety risk. There is also no danger that the friction layers may split off the base in large pieces since because the friction layers are virtually tension free due to the tension relief structure.

The tension relief structure is partially visible on new components and may vary considerably between the two brake disc chamber sides.

Thus, a brake disc with this feature is OK.

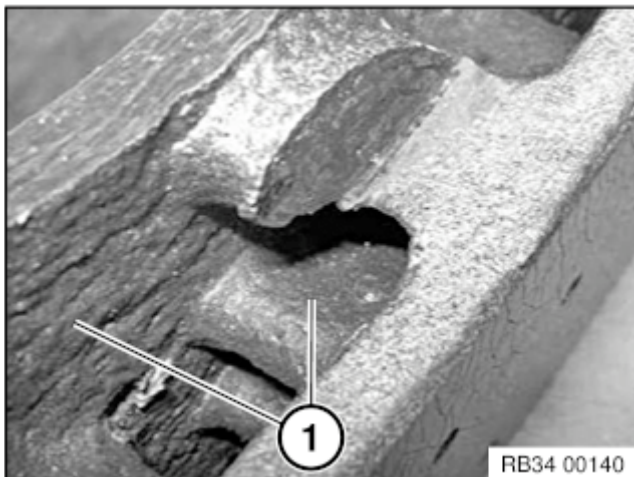
Rough surfaces in coolant duct:

The surfaces (1) in the coolant duct have a different structure. The coolant ducts are not finished and therefore have a rough structure.

Thus, a brake disc with this feature is OK.

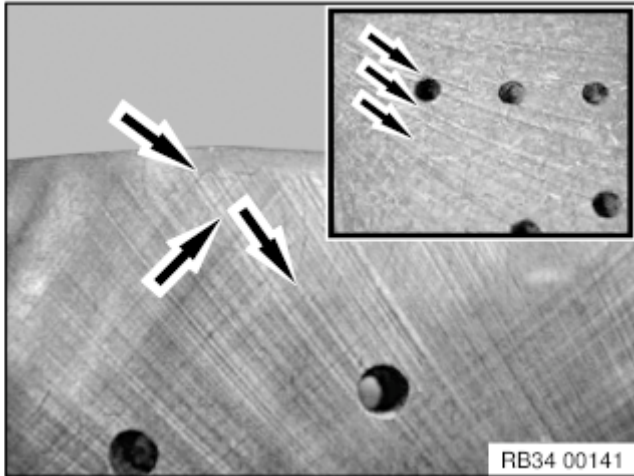
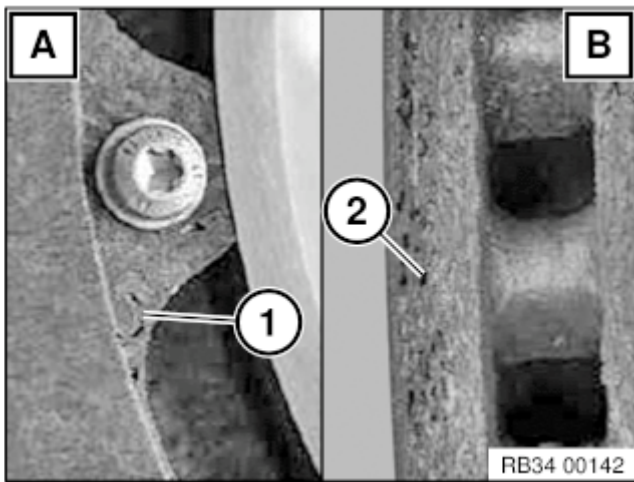
Pores in base:

Due to the carbon fibres used, with a defined length of 10 mm without a short fibre portion, visible pores arise in the base during the manufacturing process. These pores have no negative influence on the function of the ceramic brake disc.

(1) Pores on brake disc chamber screw connection

(2) Pores on the brake disc face

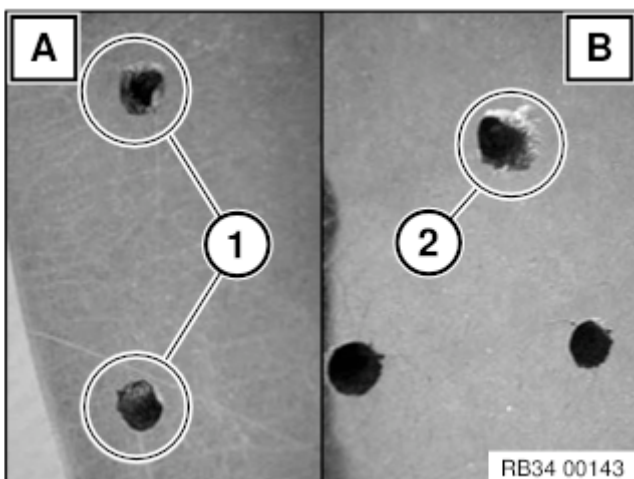
Flaws on perforation bore holes

(1) Brake disc OK

(2) Brake disc not OK -> nest-shaped pittings

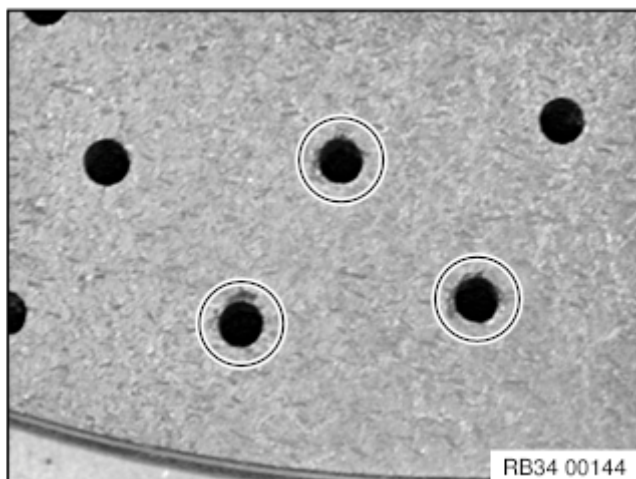
Brake disc not OK

-> Nest-shaped pittings (3 or more holes on each side)

| Nature | Perforation bore holes with edge pittings |
| Remarks | Edges widened due to edge pittings |
| Fulfilment criteria | <p>No edge pittings at perforation bore hole</p> <p>Permissible pittings are those that:</p> <ul style="list-style-type: none"> - are no larger than >3 mm starting at the hole edge - end within the friction layer - are not nest-shaped (3 or more bore holes next to each other) |
| Max. number | 20 affected bore holes on each side |

| Measures | If not OK, do not install component |

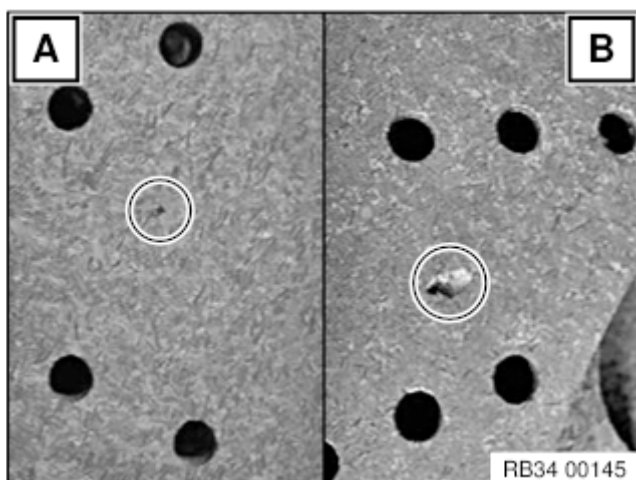
Pittings in friction layer:

Image (A). Brake disc OK

Image (B): Brake disc not OK

| Fulfilment criteria | <p>No pittings</p> <p>Permissible pittings are those that:</p> <ul style="list-style-type: none"> - end in the friction layer - if not > 2 x 2 mm |
| Max. number | 1 pitting per side |

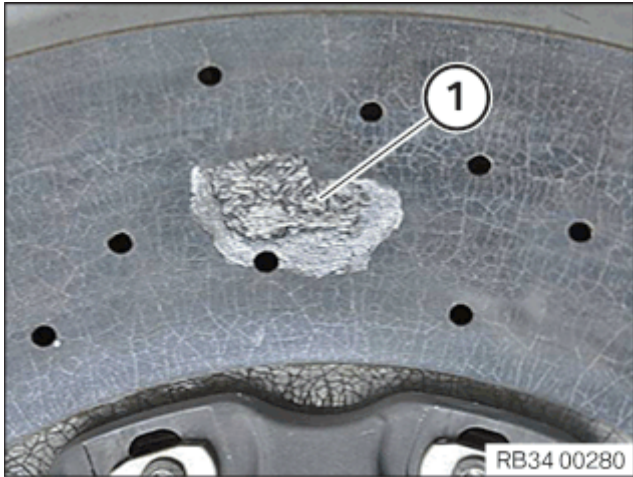
Partial spalling (1) of the friction layer has no influence on the function or safety of the brake system (no comfort disadvantages or uneven braking force distribution).

The separation is a purely visual defect, but may cause customer disappointment and uncertainty.

If the pitting/spalling (1) has reached 2x2 mm, these ceramic brake discs can be replaced. They must be returned through the special defective parts channel, as that is the only way that a refund (applicable only to the warranty period) can be made.

If not OK, do not install component

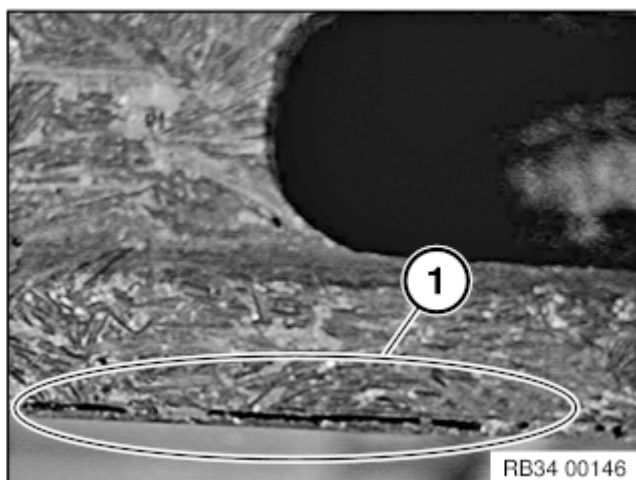
Friction layer detachment:

Brake disc with friction layer detachment (1) -> brake disc not OK.

| Nature | Friction layer detachment |
| Remarks | Gap between friction layer and base |
| Fulfilment criteria | Friction layer detachment not permissible |

| Measures | If not OK, block component |

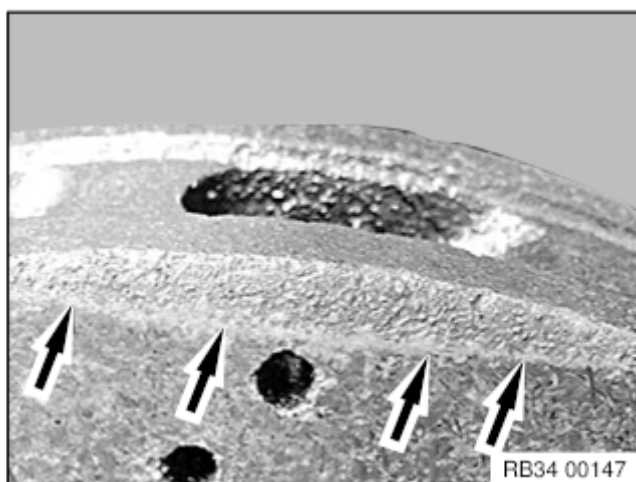
Fiction layer not fully finished:

Brake disc (see image) not OK

| Nature | Fiction layer and edge not fully finished |
| Fulfilment criteria | Ful, uniform finishing of surface |

| Measures | If not OK, do not install |

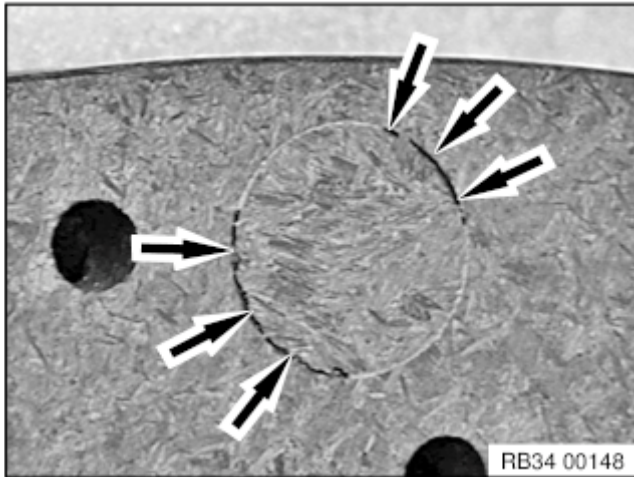
Gap between friction layer and base

Brake disc (see image) not OK

| Nature | Bore hole in the friction layer is too large for the wear indicator with 14 mm diameter; a gap occurs between friction layer and wear indicator |
| Remarks | On friction layer 3406, only a wear indicator with a 14 mm diameter is used |
| Fulfilment criteria | No gap between wear indicator and friction layer |

| Measures | If not OK, do not install component |

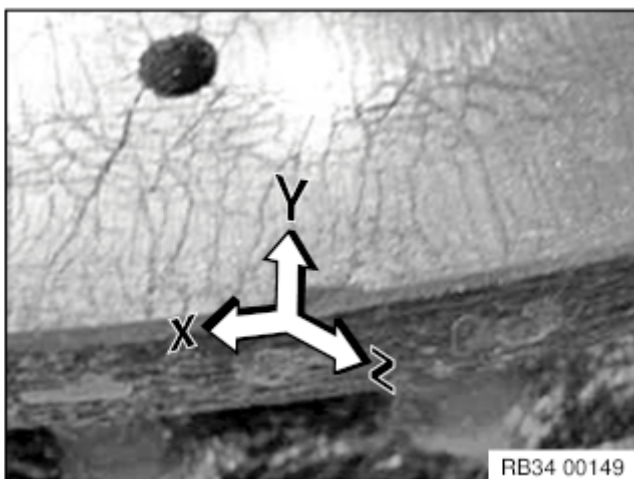
Splitting off on outer edges of friction ring:

Brake disc (see image) OK

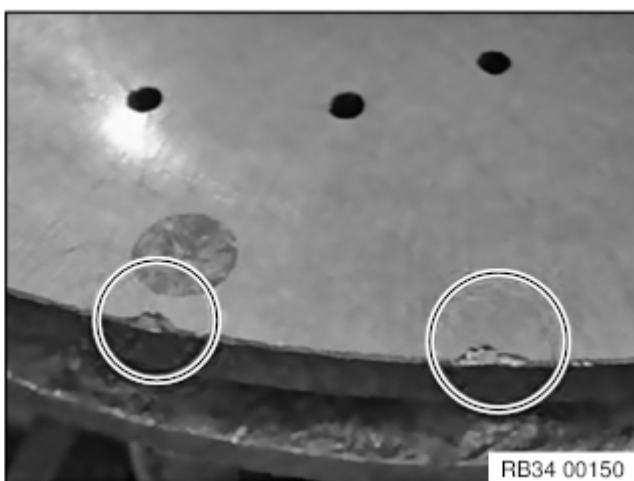
Brake disc (see image) not OK

| Nature | Splitting off on outer edges of friction ring |
| Remarks | Irregular outer contour due to material and finishing properties of friction layer or Damage due to improper handling of brake disc |
| Fulfilment criteria | No edge damage The following is permissible: - max. damage length: 10 mm (x) - max. damage width: 3 mm (y) - max. damage depth: 3 mm (z) |
| Max. number | 1 per side |

| Measures | If not OK, do not install component |

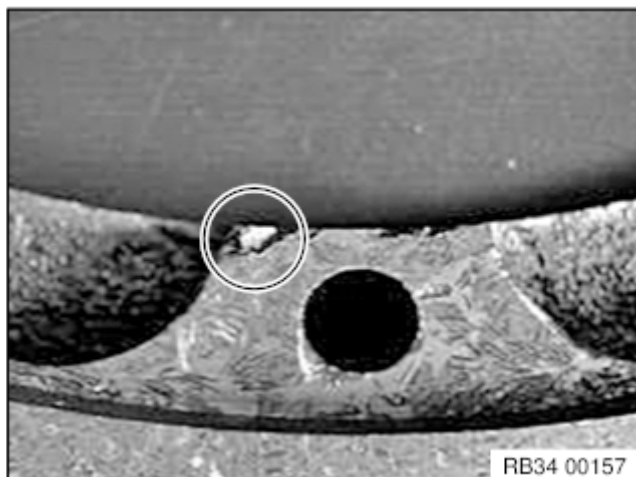
Edge pittings in rib area:

Brake disc (see image) not OK

| Nature | Edge pittings in rib area |
| Fulfilment criteria | No edge pittings The following is permissible: - outside of nut support with a surface $\geq 25 \text{ mm}^2$ |
| Max. number | 5 connection areas with pittings |

| Measures | If not OK, do not install component |

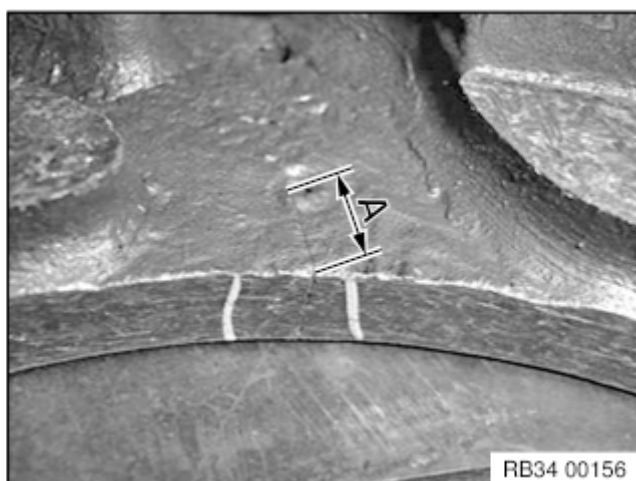
Radial cracks on inside circumference of brake disc ring

Brake disc (see image) OK

| Nature | Radial crack on inside circumference of brake disc ring |
| Remarks | Due to intrinsic tension in the brake disc ring, radial cracks may occur |

| criteria | permissible: - Cracks up to 10 mm in length |
| Max. number | 5 cracks are permissible |

| Measures | If not OK, do not install component |

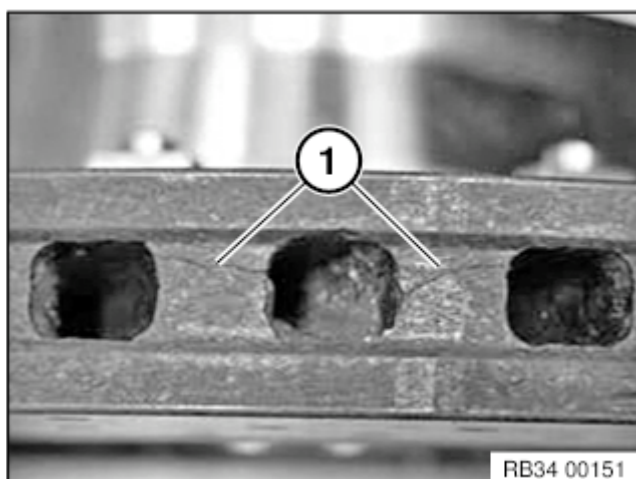
Cracks on rib transition:

Cracks (1) in rib area of brake disc

For brake disc, see image: OK

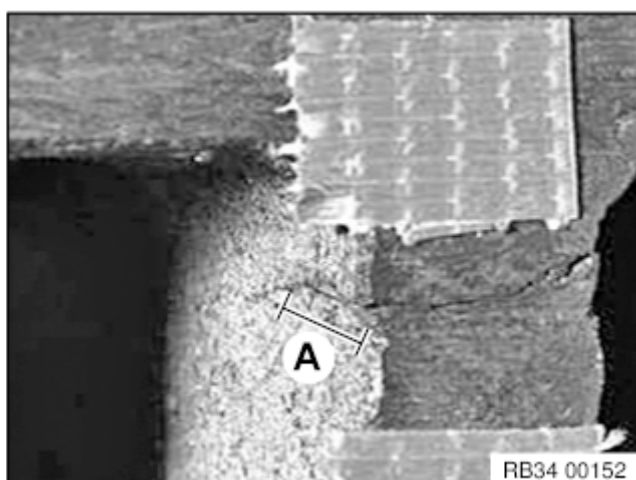
Cracks (dimension A) in rib area >20 mm deep -> brake disc not OK.

| Nature | Crack on rib transition |

| Remarks | Due to intrinsic tension in the brake disc ring, radial cracks may occur |
| Fulfilment criteria | The following is permissible: - Continuous cracks on rib \leq dimension [A] 20 mm deep |
| Max. number | Max. 10 cracks per component Not more than 5 cracks next to each other |

| Measures | If not OK, do not install component |

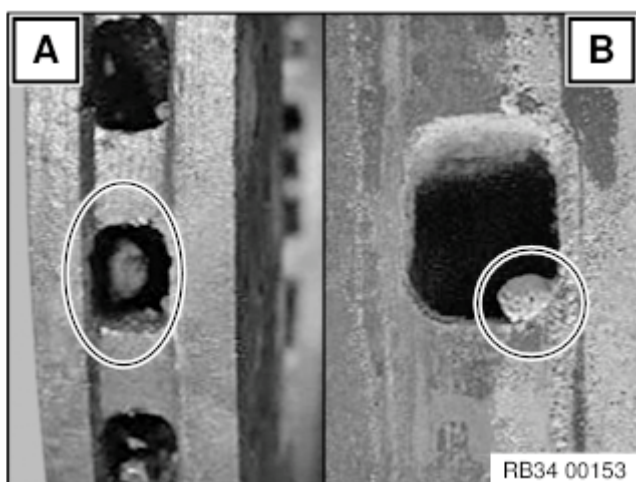
Phosphate residue in coolant duct and perforation bore holes/dirt contamination on ASSY

Image (A) and (B) -> brake disc not OK.

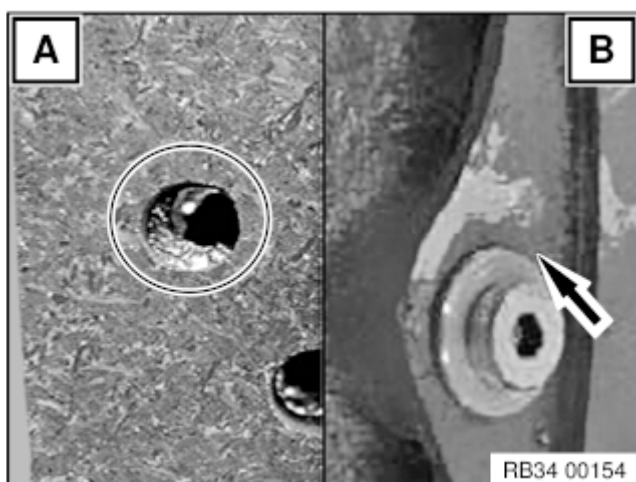
Brake discs, see image, not OK

1 Perforation bore hole

2 Contamination of ASSY

| Nature | Phosphate residue in coolant duct or perforation bore hole |
| Remarks | Coolant duct: No phosphate residue in coolant duct, perforation bore hole: - Free diameter is at |

| | <p>least 3 mm</p> <ul style="list-style-type: none"> - Constriction is circular or crescent shaped - Constriction is 2 mm below surface <p>No contamination of ASSY</p> |

| Measures | <p>If not OK, do not install component</p> |
