REP-REP-RAF1034-3400_CSIC_GRENZMUSTER Consult the boundary samples catalogue when assessing the appearance of carbon ceramic brake discs

VIN: Vehicle: 5' / F10 / Sedan / M5 / S63 / EUR / left-hand drive /
MANUAL / 2015 / -

Consult the
boundary
samples
catalogue when
assessing the
appearance of
carbon ceramic
brake discs

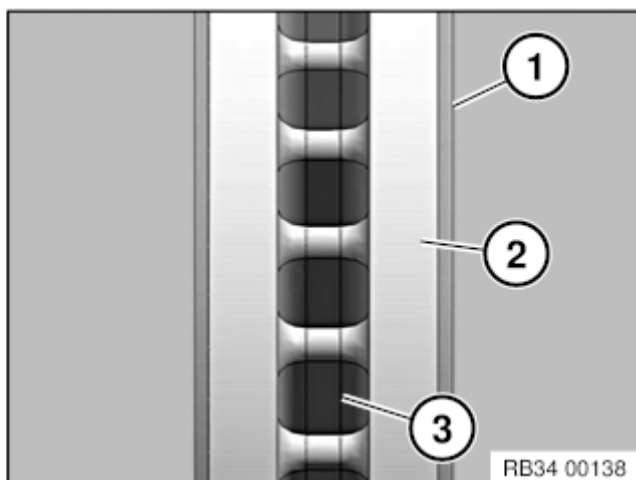
Structure of a carbon ceramic brake disc:

1. Ceramic friction layer
2. Carbon base
3. Coolant duct

To ensure that the ceramic brake disc has a long service life, the base is provided with a separate friction layer. The friction layer is bonded by means of a special joining paste. The siliconisation results in a bonded connection.

The base and the friction layer are made from different mixtures/recipes. For this reason, the two components differ in appearance.
