## REP-REP-RAF3351-5147143 REP-REP-RAF3351-5147143 - Removing and installing/replacing passenger compartment partition wall trim panel - V.2, VIN: EE18811

**Removing and installing/replacing passenger compartment partition wall trim panel**

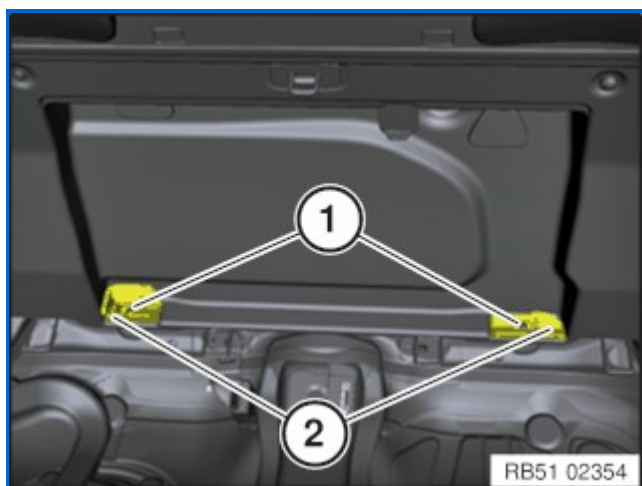
Release screws (1).

Remove wind deflector brackets (2).

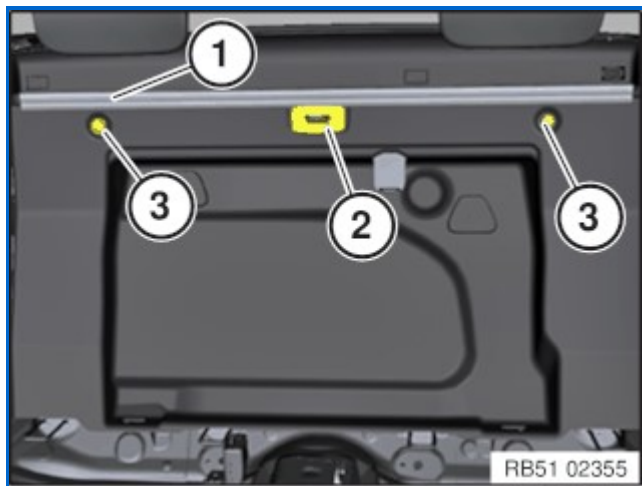
Pull off trim panel (1) towards bottom.

Remove cover (2).

Pull off buffer (3) and release screws underneath.

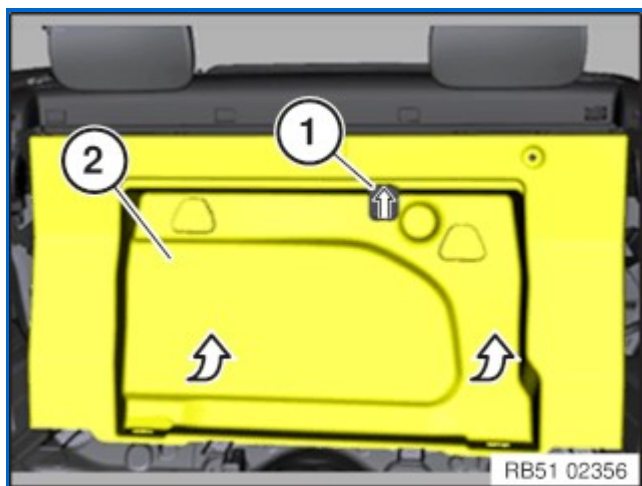
Slide locking slide for wind deflector (1) upwards.

Feed out trim panel (2) and remove.
